Penticton – A Place to Stay Forever

# MASTER PLAN PENTICTON CREEK RESTORATION

<i>Date</i>	<i>Document Name</i>	<i>Author</i>
Nov. 2017	2017 Erosion & Deposition Inspection Report	Mould Engineering
Dec. 2017	Master Plan - Penticton Creek Restoration	Mould Engineering

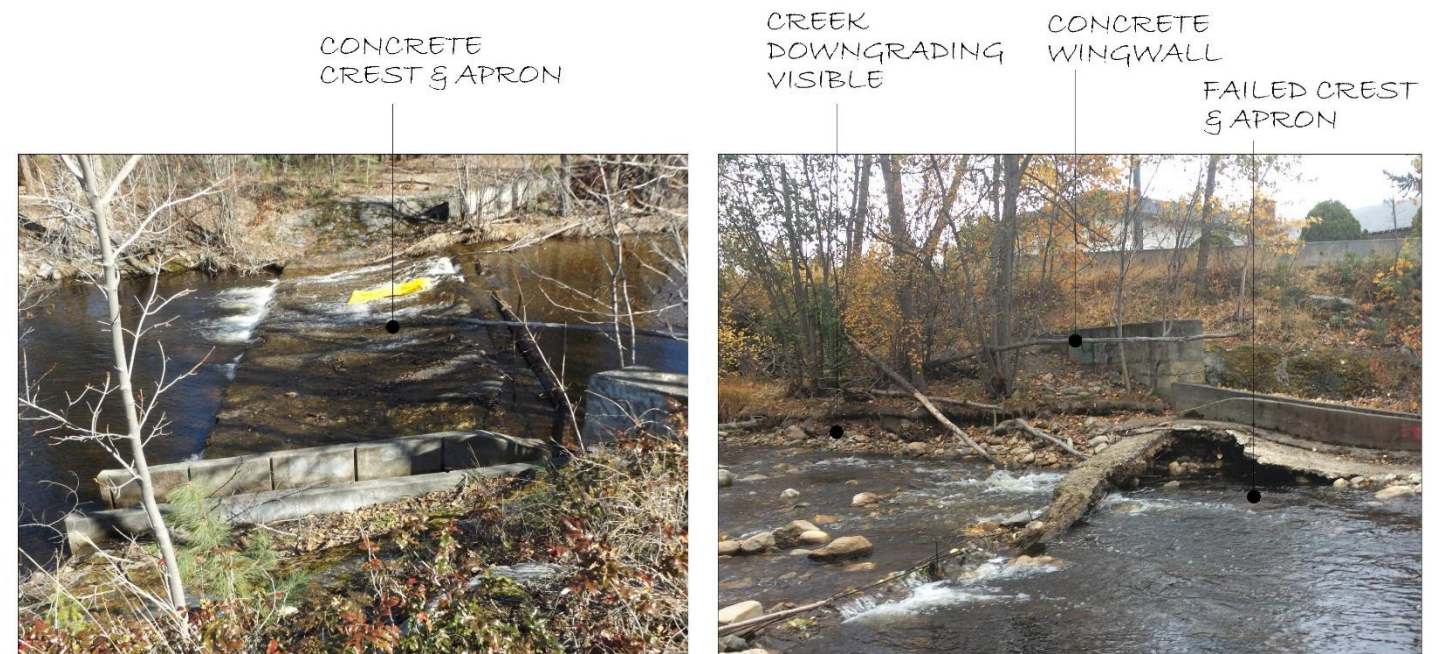
*Left: Structure #9, 2016 (facing NE)*

*Right: Failed Structure #9 after a cold winter and spring freshet, 2017 (facing SW)*

The creek is actively changing over time and as a result, the Penticton Creek Restoration Master Plan is intended to be an active document. As the infrastructure ages, it will deteriorate at an exponential rate; an example of such failure is shown in the photos above.

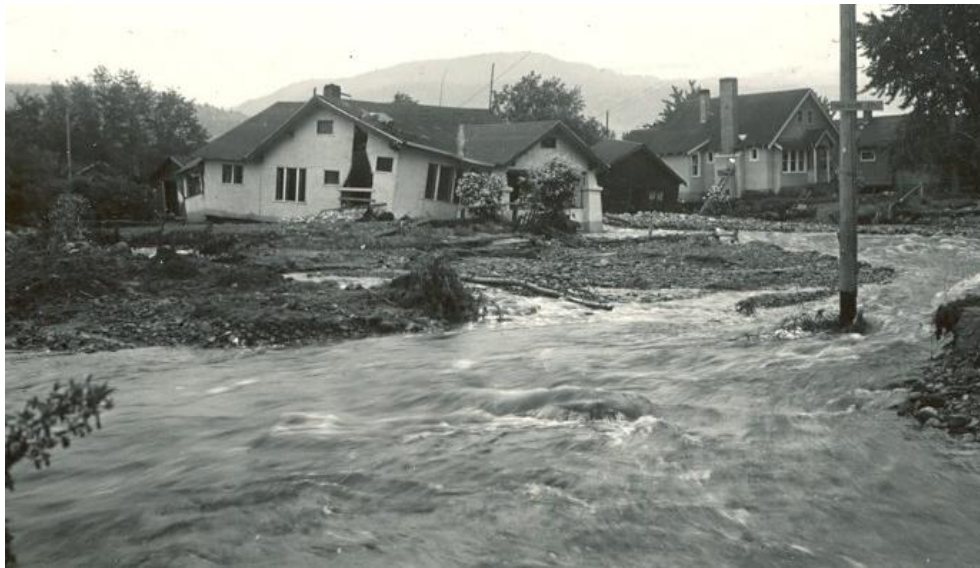
*Flooding damage at Van Horne St. & Nanaimo Ave. (Source Unknown, 1942)*

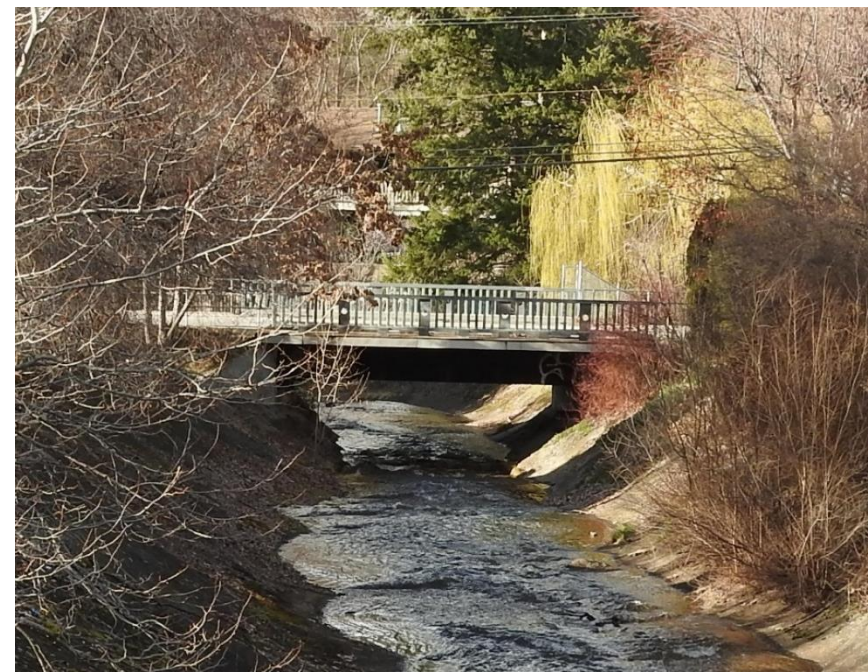
When analyzed using HEC-RAS, many of the bridges were found to have less than 1.5 metres of clearance. At higher water levels, woody debris can catch on the girders, leading to removal requirements. Therefore, a debris management program is recommended for Penticton Creek. Once in place, the governing bridge clearance requirement is 0.6 m above the  $Q_{200}$  maximum daily flow (48 cms) for all twelve bridges. The resulting clearances between the underside of the bridge girders and the water level can be seen in Annex F. Two bridges were found to have 1.5 metres of clearance or more and four bridges have between 0.6 metres and 1.5 metres of clearance, which are considered acceptable. The remaining six bridges are deficient and two of these have no clearance. As can be seen in the photo below, the cross-sectional area narrows at Forestbrook Drive bridge, which is common at most of the bridges on Penticton Creek.

Channel Narrowing at Forestbrook Drive bridge

The options for improving bridge clearance are to increase the cross-sectional area beneath the bridge by widening or deepening the channel. Alternatively, bridge replacement, or removal could be considered. The recommendations for each deficient bridge are discussed in the Revitalization section.

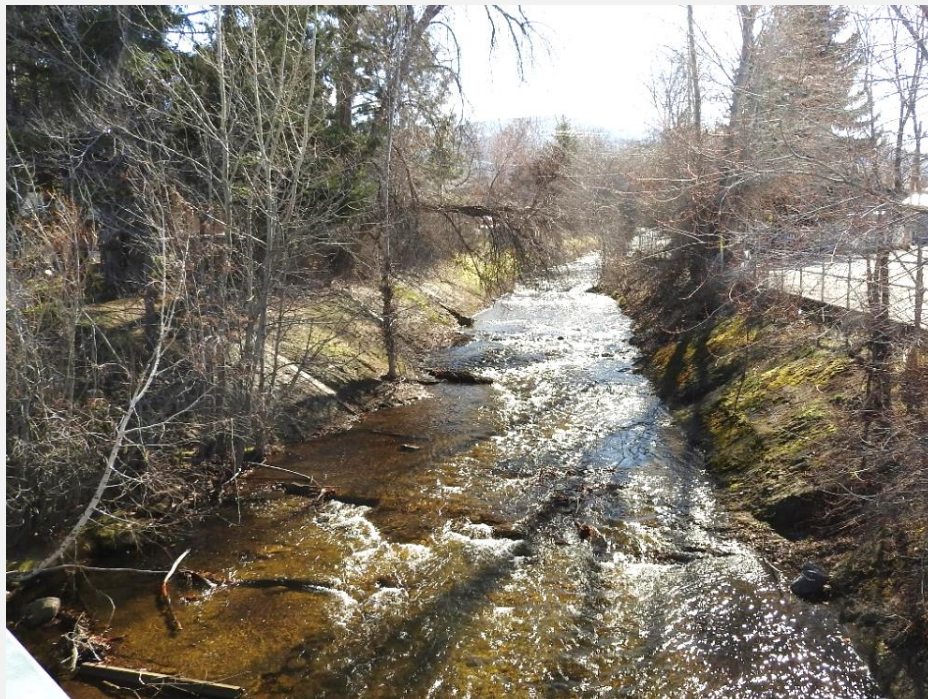
Reach 3 is narrow, concrete lined section of creek that includes Structure #2, the tallest structure measuring 2.7 m in height. The concrete lining is deteriorating, exposing a wire mesh in many locations. Approximately every 10 metres, a cutoff beam spans the creek. These beams measure approximately 0.4 metres wide and over one metre deep, and are presumed to have been constructed to add stability to the creek and prevent downgrading.

*Looking upstream From Nanaimo Avenue Bridge*

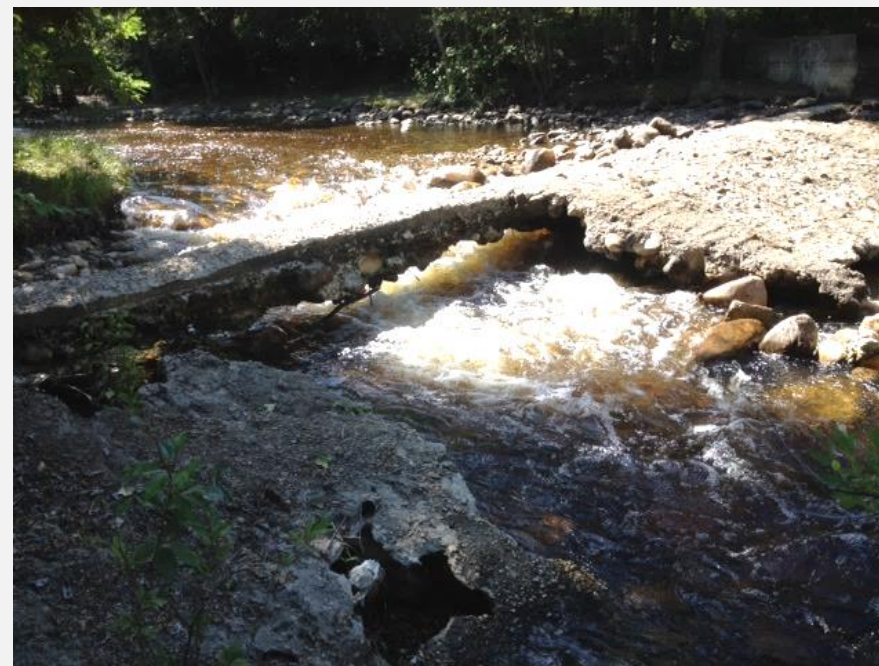
*A failed concrete structure in Reach 9*

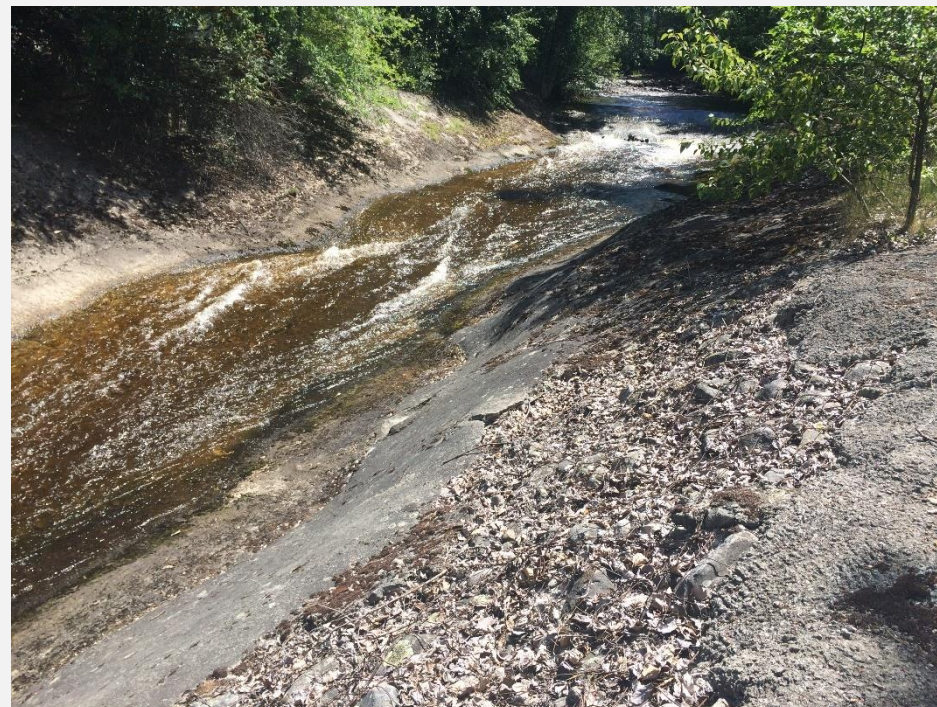
*A concrete lining hole with visible mesh*

Each structure will be replaced with two to three riffles.

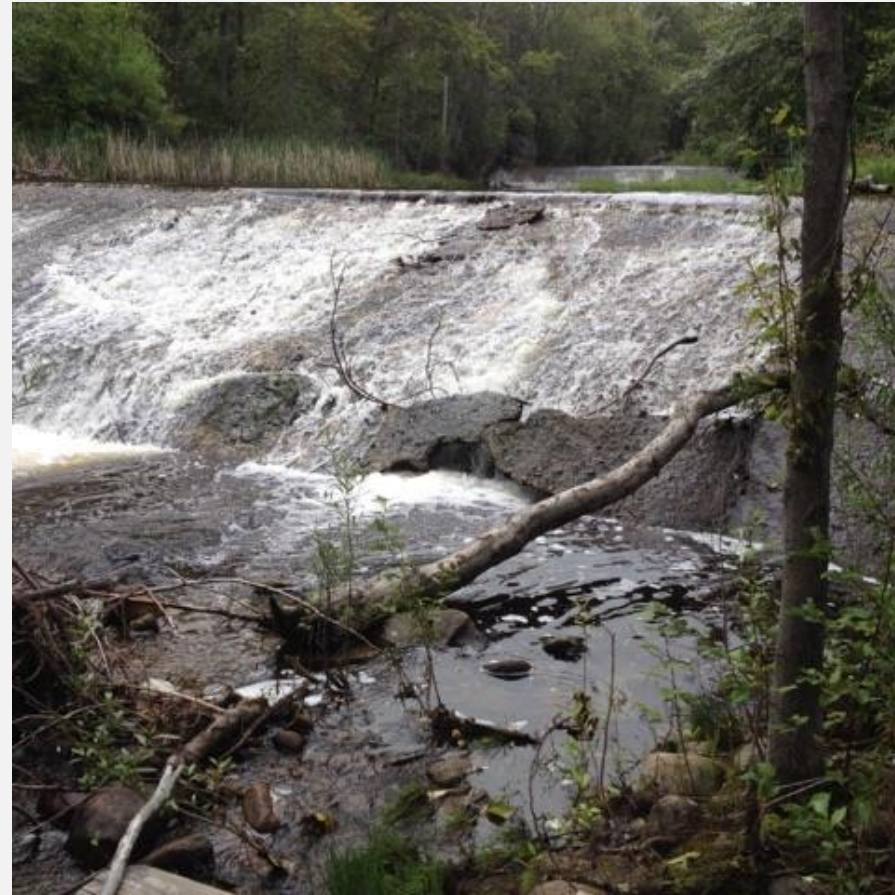
*Water flowing under the concrete apron of Structure #36*
