# ELLIS CREEK

# MASTER PLAN

Prepared by:  
Stantec Consulting Limited.

March 18, 2020

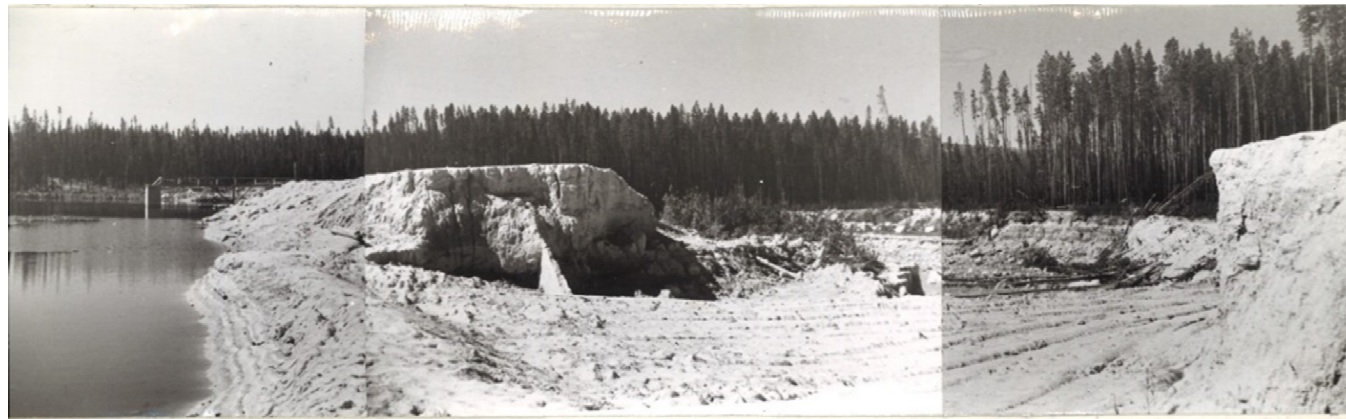
**Breach of Ellis Creek No. 4 Dam (May 1941)**

On May 12, 1941, the Ellis Creek No. 4 dam failed, releasing ~ 740 000 m<sup>3</sup> of water that reached Penticton. The flood destroyed the Ellis Creek intake, as well as portions of the North and South Ellis flumes. The floodwaters in Penticton inundated orchards and residences, streets and the highway. Debris from the floodwaters were transported to the Okanagan River where a log jam formed.

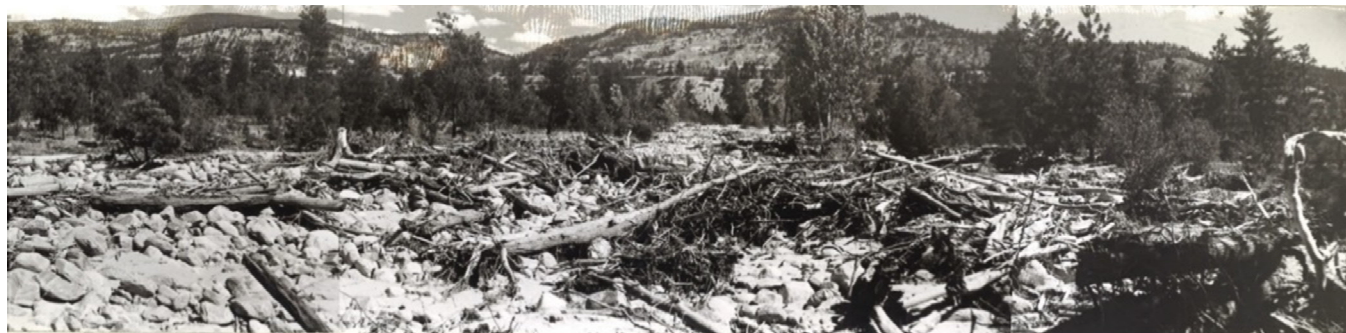
**Flood Damage on IR2 From the Breach of Ellis Creek No. 4 Dam (May 1941)**

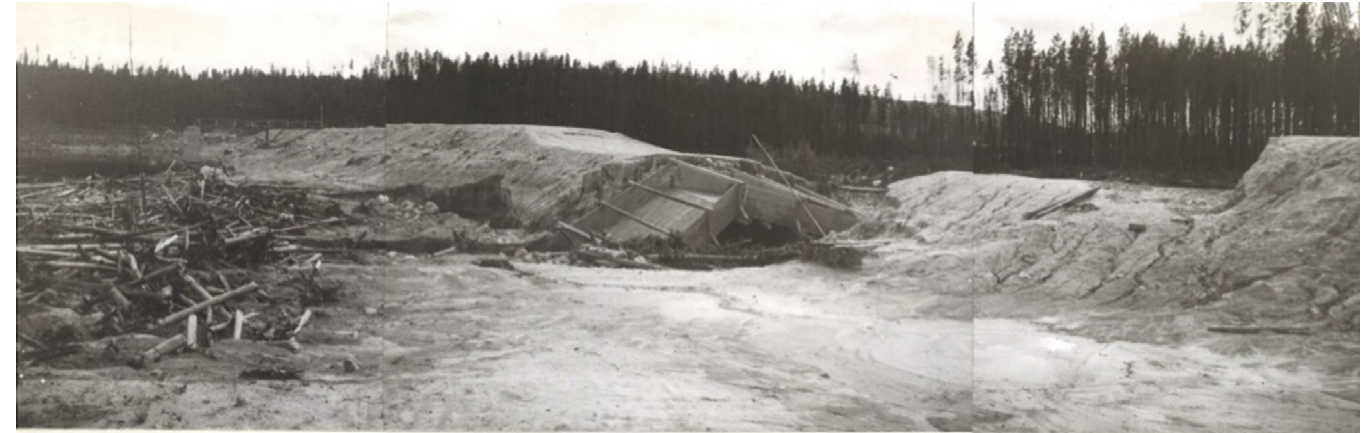
**Breach of the Temporary Timber Spillway on Ellis Creek No. 4 Dam (May 1942)**

On May 23, 1942, the Ellis Creek No. 4 dam partially failed in the site repaired from the previous breach. The floodwaters caused further damage in Penticton.

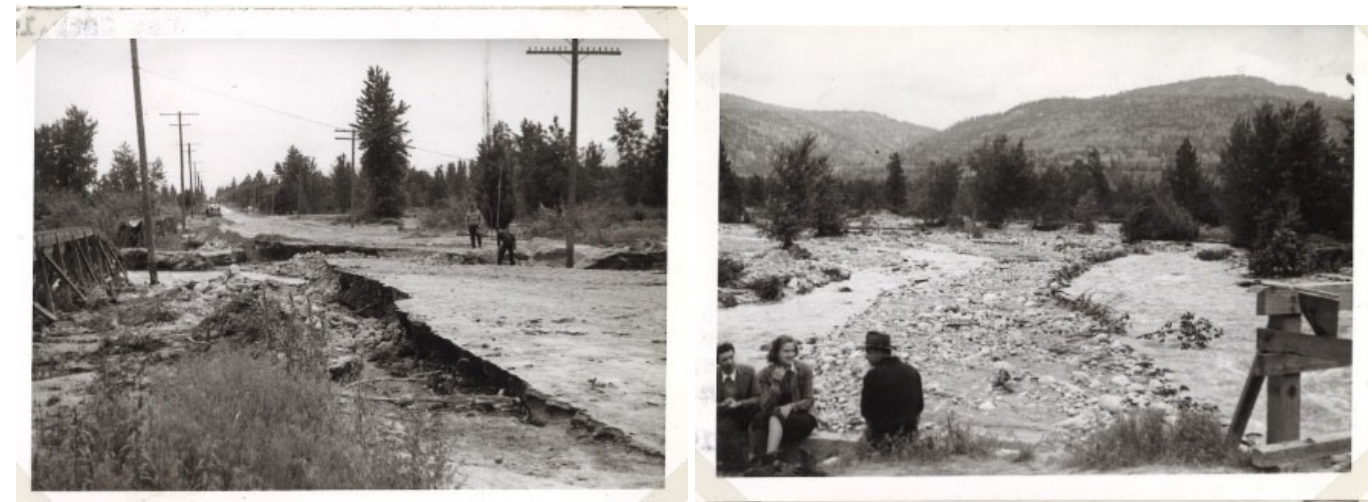
**Resulting Flood Damage Downstream of Breach on Ellis Creek No. 4 Dam (May 1942)**

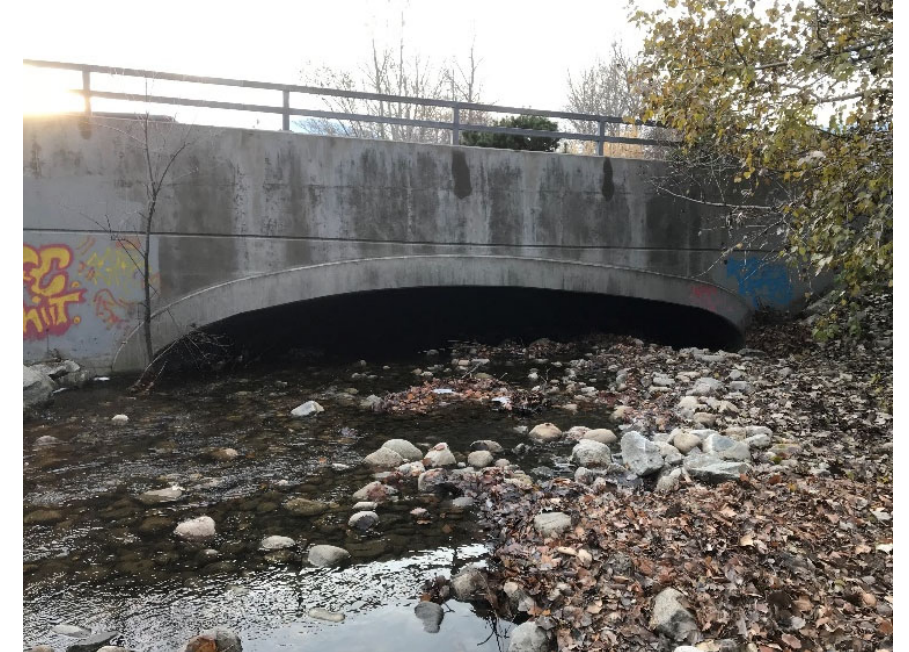
The Ellis Creek channel shows evidence of aggradation in some reaches and degradation in other reaches. Results of the analysis are found in Table 11.

**Aggradation in Ellis Creek Channel (Industrial Avenue Bridge)**

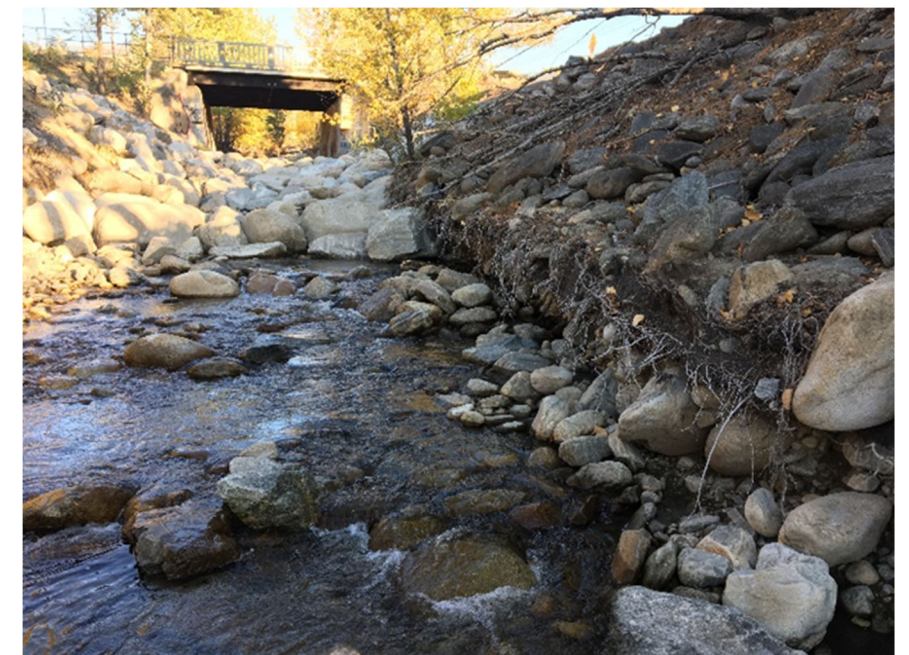
**Degradation in Ellis Creek Channel (Dartmouth Road Bridge)**

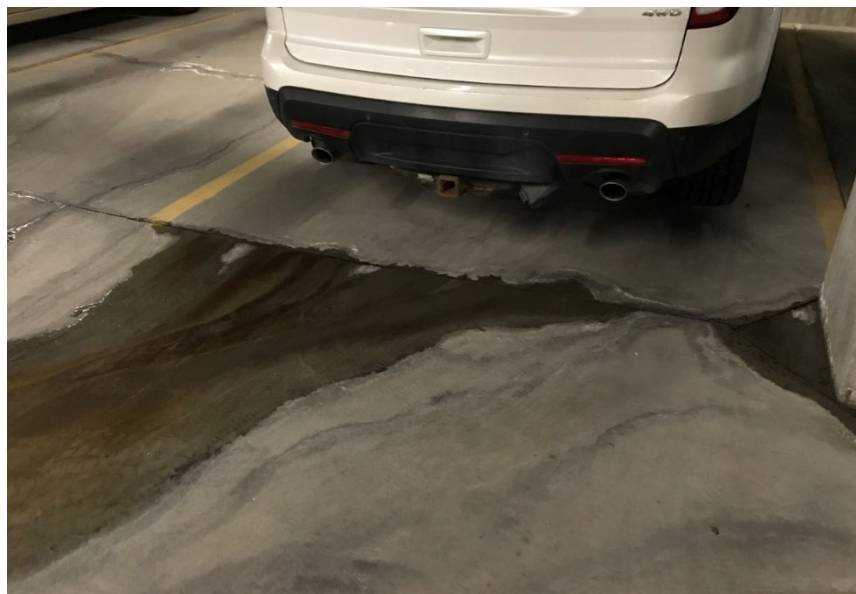
**Figure 11. Water Seepage in a Parking Garage**

Climate change may have also contributed to increased ground water levels. Annual precipitation at Penticton has increased since 1960. Groundwater levels may increase with increasing precipitation, and it is possible that the high-groundwater levels represent a new normal for this part of Penticton.

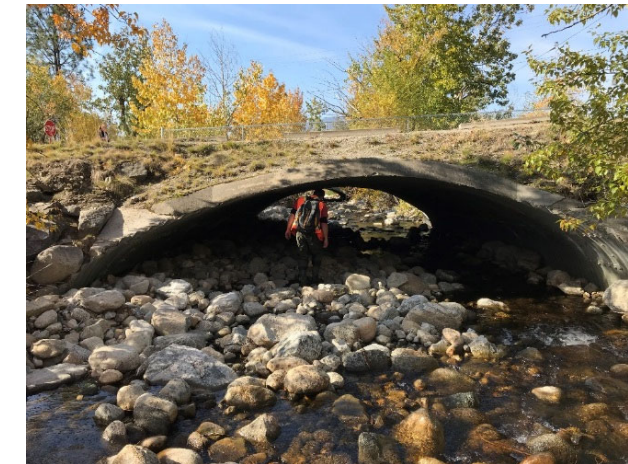
- Seven (7) open bottom culverts and four (4) clear-span bridges
- Notable reduction in opening area at Government St to EC Dog Park bridge caused by sediment deposition
- Notable erosion at Dartmouth Rd bridge
- Three (3) exposed/damaged utility crossings at Dartmouth Rd Bridge
- Numerous damaged/non-functional stormwater outfalls

**Deposition at East Hospital Access Bridge**

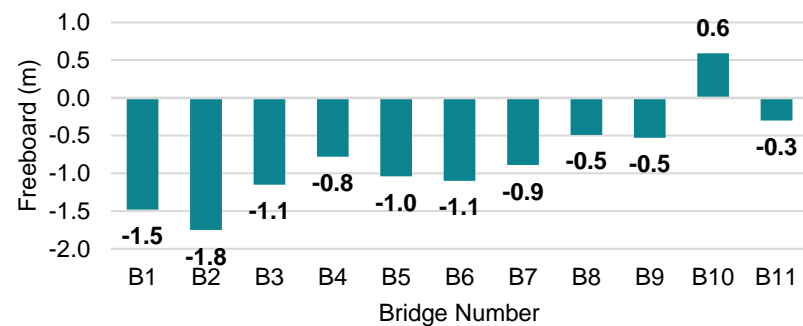
Ten (10) of the 11 bridge crossings on Ellis Creek within the study area do not convey the 200-year design flow event (Figure 15). Live-bed conditions (i.e. bedload transport) occur at the Site in conjunction with the design flow event and will also influence the total conveyance capacity of the crossings.

**Figure 15. Summary of Freeboard at Ellis Creek Bridges**

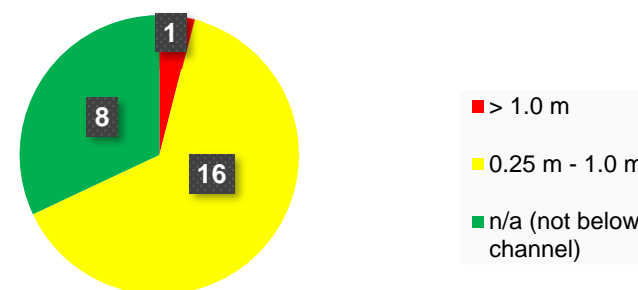
Although the risk evaluation is limited to the design event, it is prudent to consider exposure risks at the listed crossings during events with return periods lower than the 200-year design flow event. Specifically, the utility crossings located in degraded reaches have a high likelihood of low depth of cover and therefore are more likely to be vulnerable to damage during lower return period events. A summary of the natural scour potential is illustrated (Figure 16) by ranges of estimated scour depth in meters below channel bottom.

**Figure 16. Summary of Potential Scour Depths at Utility Crossings**
