Penticton – A Place to Stay Forever

# MASTER PLAN PENTICTON CREEK RESTORATION

<i>Date</i>	<i>Document Name</i>	<i>Author</i>
Nov. 2017	2017 Erosion & Deposition Inspection Report	Mould Engineering
Dec. 2017	Master Plan - Penticton Creek Restoration	Mould Engineering

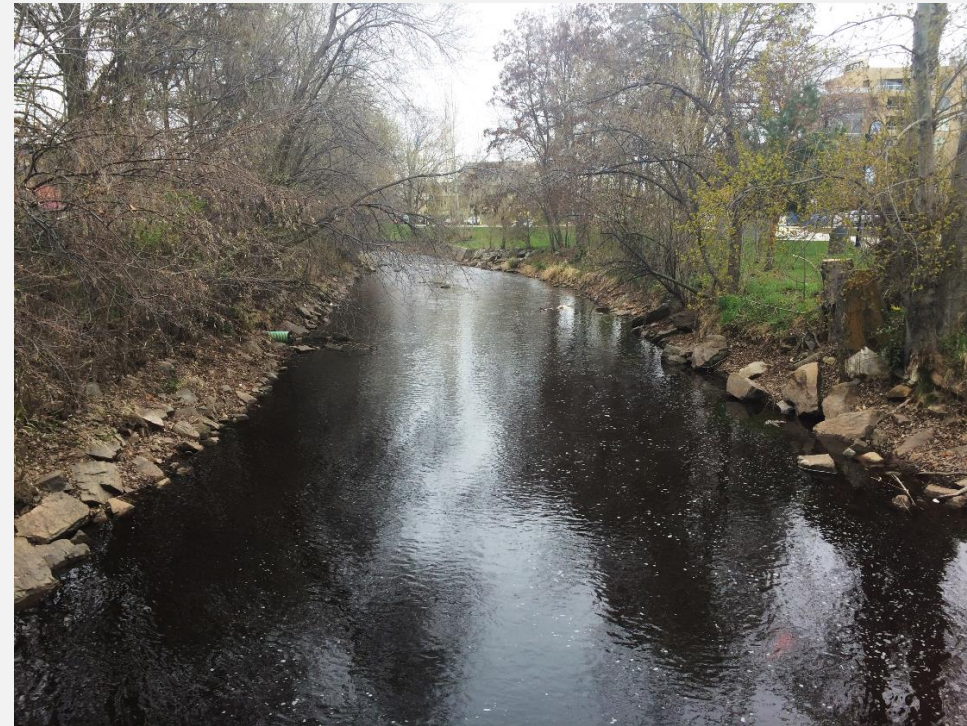
*Upstream of the Art Gallery Pedestrian Bridge*

A large alder stump was identified as a marker of archaeological potential. Thule reeds were also found on the banks and are considered valuable to the Syilx people.

There is considerable variation in bank armoring and some of the smaller sized material will be unstable at higher flows. The short retaining wall on the west side of the creek is currently failing and the Art Gallery pedestrian bridge does not have the required clearance at high flows.

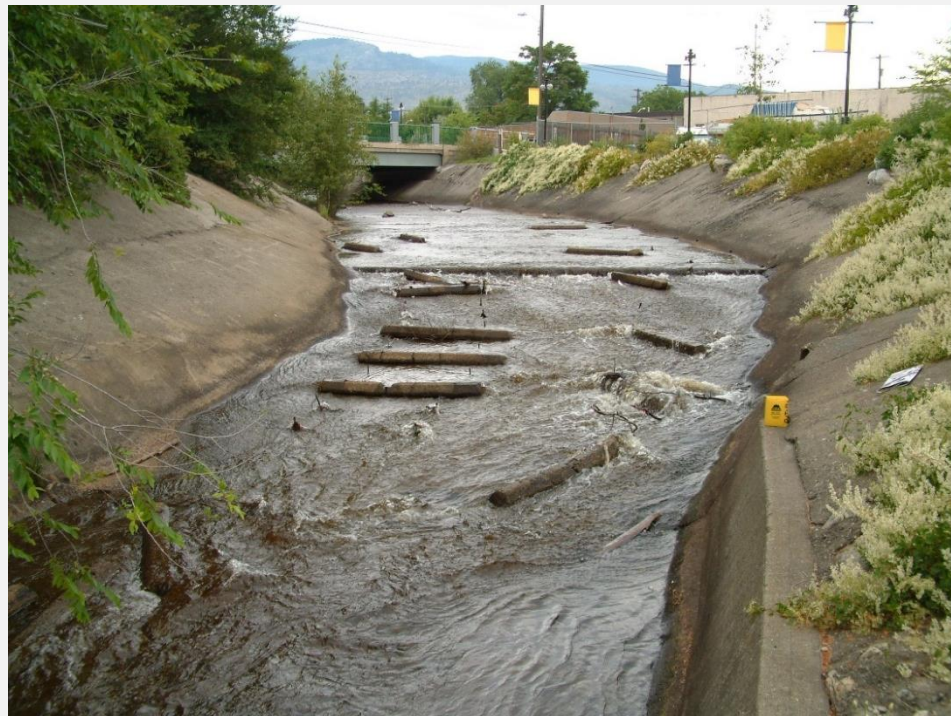
*Looking upstream at Structure #1*

Reach 2 is the narrowest, and most urban, section of creek with an average bottom width of 6 metres. The entire reach is concrete lined and differs from the other lined reaches as the concrete was formed, and is generally in better condition than the reaches that were not formed (Reaches 3, 5, 7 and 10). However, there are still many holes in the lining. As can be seen in the existing photos, vegetation including shrubs and

The first potential option is a simpler design that incorporates rock banks; however, concrete retaining walls are still needed to ensure that the minimum freeboard requirements are met. This option creates a low flow channel with small riffles to assist in migration. A series of riffles will be needed to replace Structure #1, in Reach 2b.

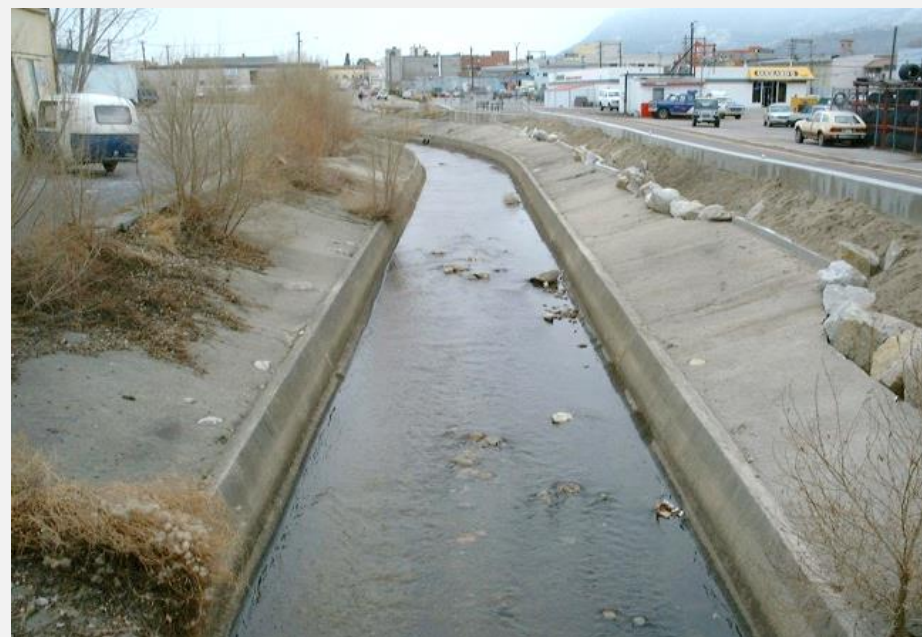
*Formed concrete lining, facing upstream*

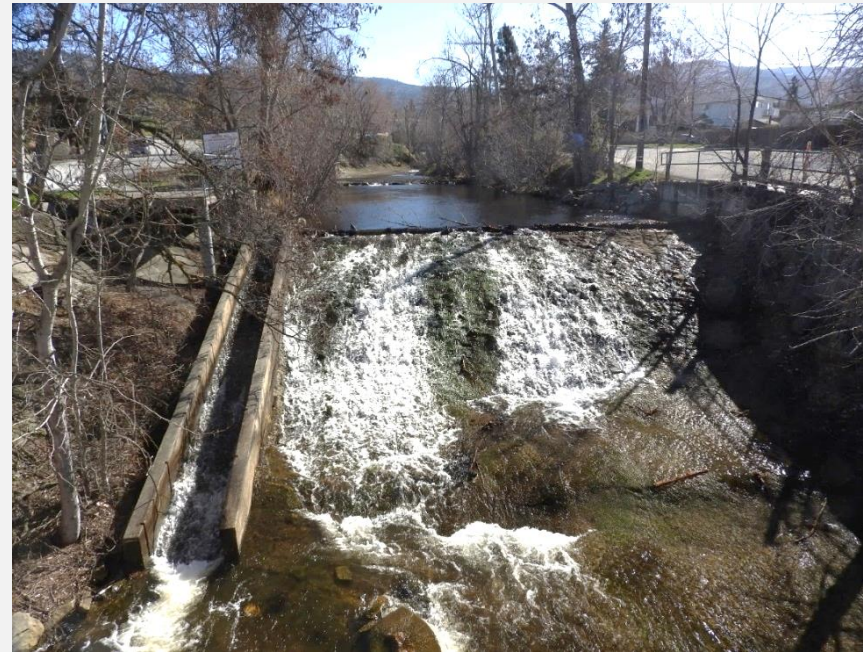
Reach 3 is narrow, concrete lined section of creek that includes Structure #2, the tallest structure measuring 2.7 m in height. The concrete lining is deteriorating, exposing a wire mesh in many locations. Approximately every 10 metres, a cutoff beam spans the creek. These beams measure approximately 0.4 metres wide and over one metre deep, and are presumed to have been constructed to add stability to the creek and prevent downgrading.

*Looking upstream at Structure #2, From Wade Avenue Pedestrian Bridge*

The Wade Avenue pedestrian bridge has adequate clearance. However, there is a lack of clearance at Nanaimo Avenue bridge and a lack of freeboard at two bank locations, and at the crest of Structure #2. The risk rating of Structure #2 is very high due to the height and current condition of the structure. The failing apron has created large holes where the material behind the structure can be seen.

In order to replace Structure #2 and create a channel that is fish passable, the restoration design for Reach 3b will create a series of riffles and pools for approximately 180 metres. The overall slope of the design will be steeper than the existing channel, therefore taking advantage of the additional freeboard downstream of the structure. By raising the creek profile, the bottom width will increase, creating better habitat conditions for fish.

Because there is a lack of freeboard at the current structure crest, the crest of the top riffle will be located approximately 15 metres upstream, in the existing Reach 4. The viewing area just above the crest on the east side of the creek will be removed and a replacement viewing feature could be considered.

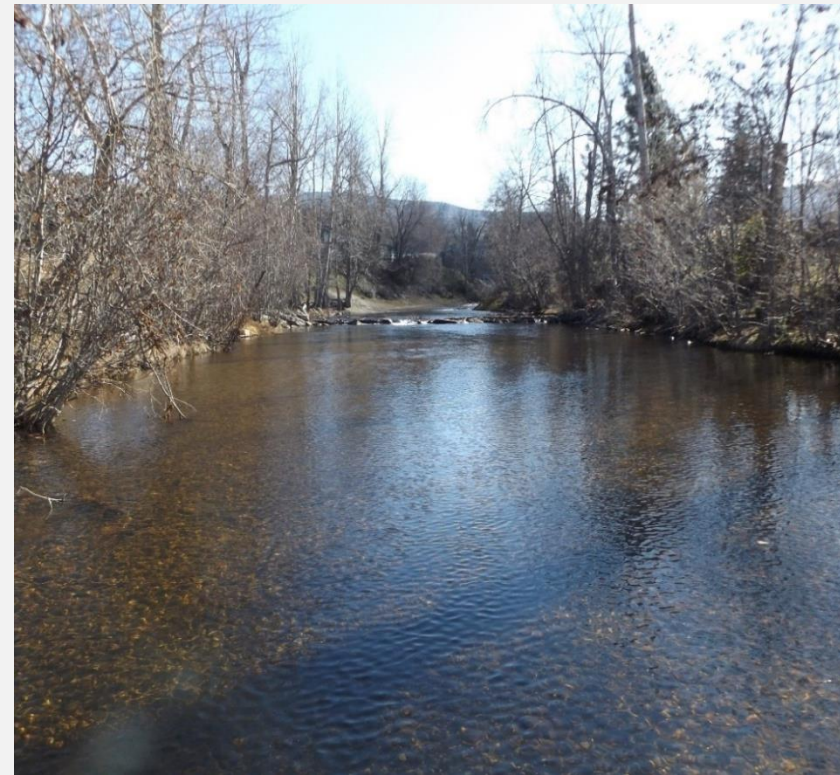
Reach 4 is a wider, flat reach that is currently used as an artificial spawning bed by the Penticton Flyfishers Club. The channel banks and bottom are not lined, and are artificially augmented with gravels after a large freshet event. The creek bottom is very flat and combined with the width, creates a very low depth of water. Parking curbs are placed across the crest of Structure #2 to create greater depths for spawning.

The only flood deficiency in this reach is at the crest of Structure #2, as mentioned in the Reach 3b writeup. There are no structures or lining. The CHIM report observed limited archaeological potential in Reach 4.

Looking upstream at Reach 4

Therefore, the proposed design would create a narrower low flow channel, within the existing banks, that would provide additional water depth and a more natural channel shape. This channel could meander and include woody debris and larger rocks to improve habitat diversity. Rather than creating a designated spawning bed in Reach 4, more natural pockets of spawning areas were desired by the PCRI Committee. The low flow channel is designed to create preferred spawning depths and velocities. Gravel augmentation will still be required in this area, as the overall channel width will not change. The lower Reach 4 boundary will need to be revised, as the replacement of Structure #2 will move the crest upstream approximately 15 metres.

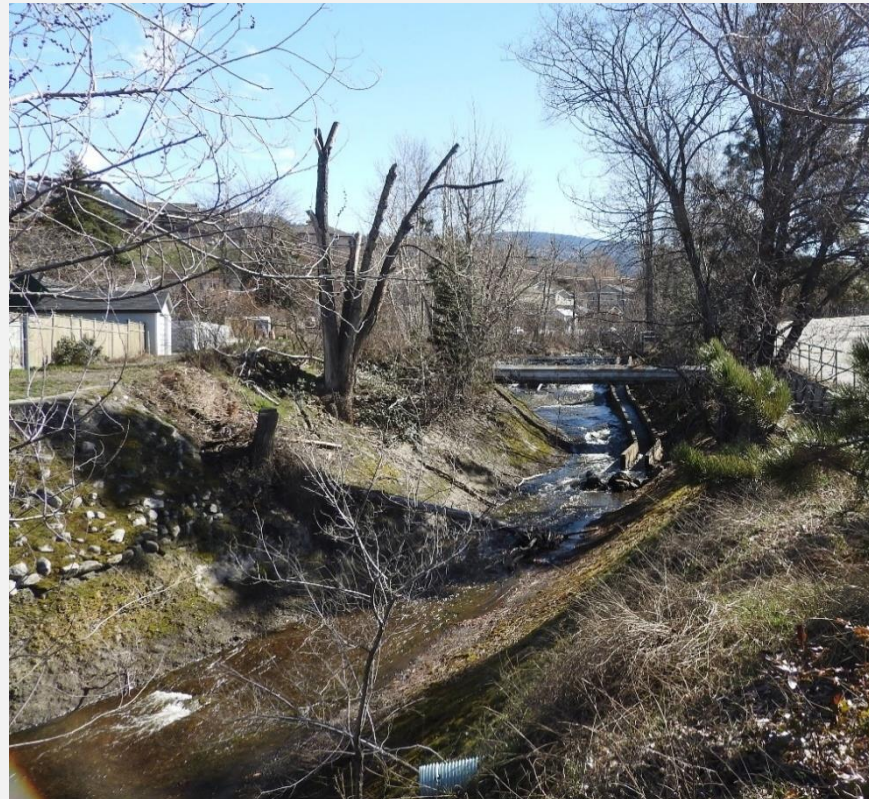
The flood infrastructure deficiencies in this reach include the lining and Structure #3. The lining is deteriorating with many holes showing mesh lining and growing vegetation. Structure #3 is the second tallest drop structure in the creek, measuring 2.3 metres. There are many holes in the apron and woody debris was observed caught on the structure and lining below.

The channel below Structure #3 is a fish barrier due to the creek velocity and smooth concrete lining, lacking resting places. Structure #3 does have a fish ladder; however, it is understood that it is rarely utilized by migrating fish due to the numerous downstream barriers.

*Looking upstream at the aboveground sewer crossing and Structure #3*

The proposed design for Reach 5 is the same riffle and pool design as proposed for Reach 3b. The height of Structure #3 requires raising the creek bed throughout the entire reach to create a fish passable channel. As the centreline profile is raised, extra width is created; however, additional widening is recommended on the east side to remove the pinchpoint. Because there is adequate freeboard at the crest of Structure #3, the crest of the new riffle design can be located at the same elevation and location as the existing crest.

Widening of the creek at the pinch point will require the relocation or replacement of the 200 mm sanitary sewer crossing, which runs east to west over the creek. There are numerous options for the sewer and Investigation will be necessary to determine the preferred design.

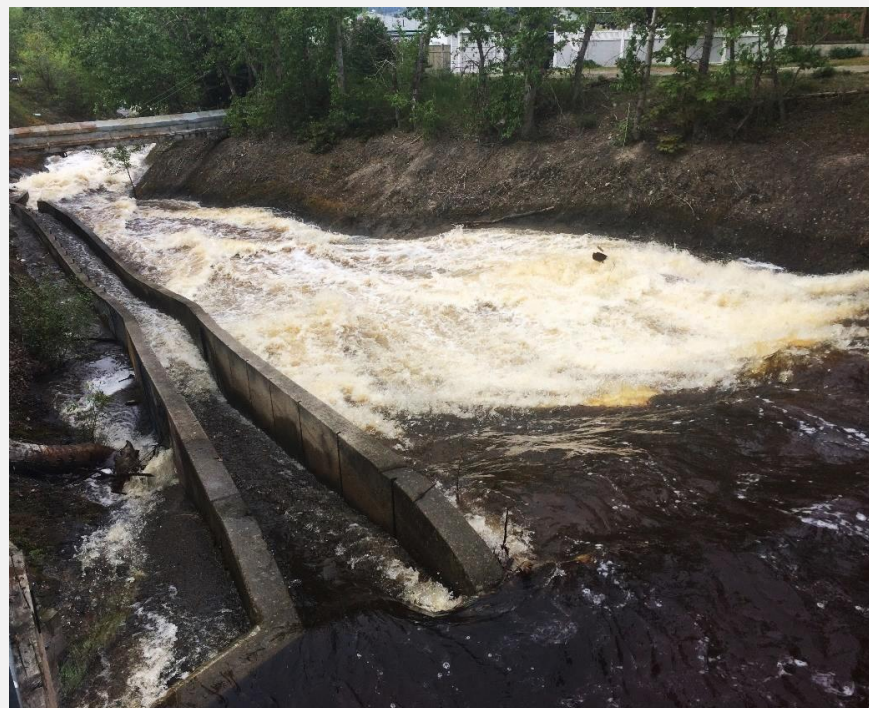
*Looking downstream from the crest of Structure #3, during spring freshet*

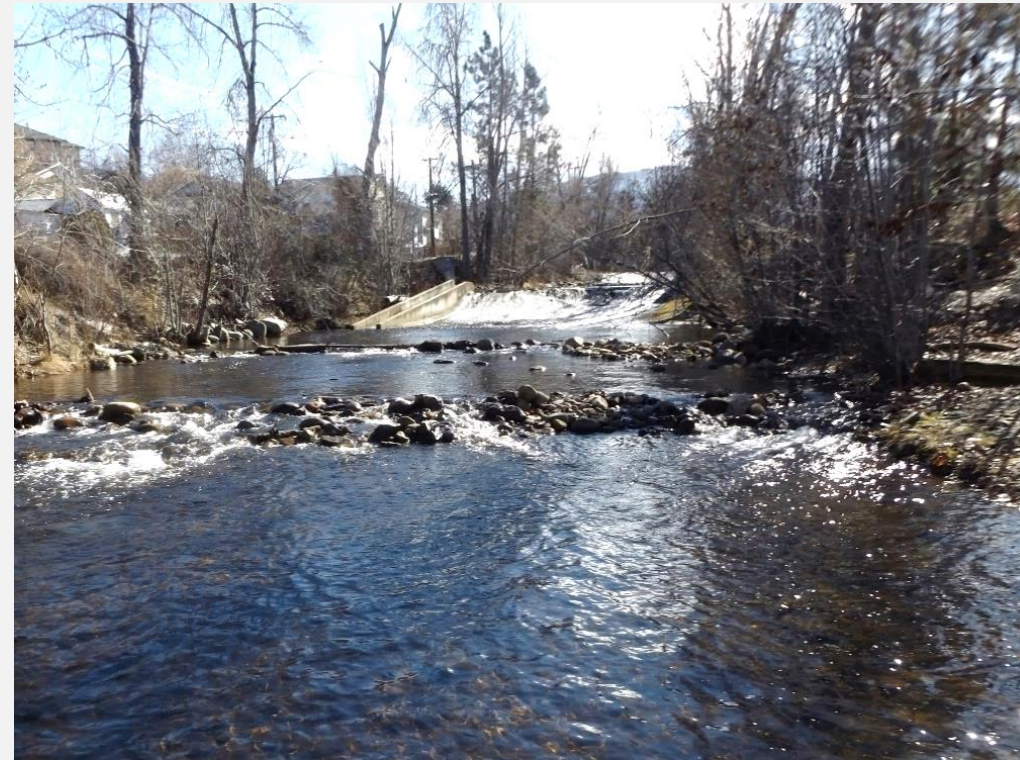
*Looking upstream from Structure #2*

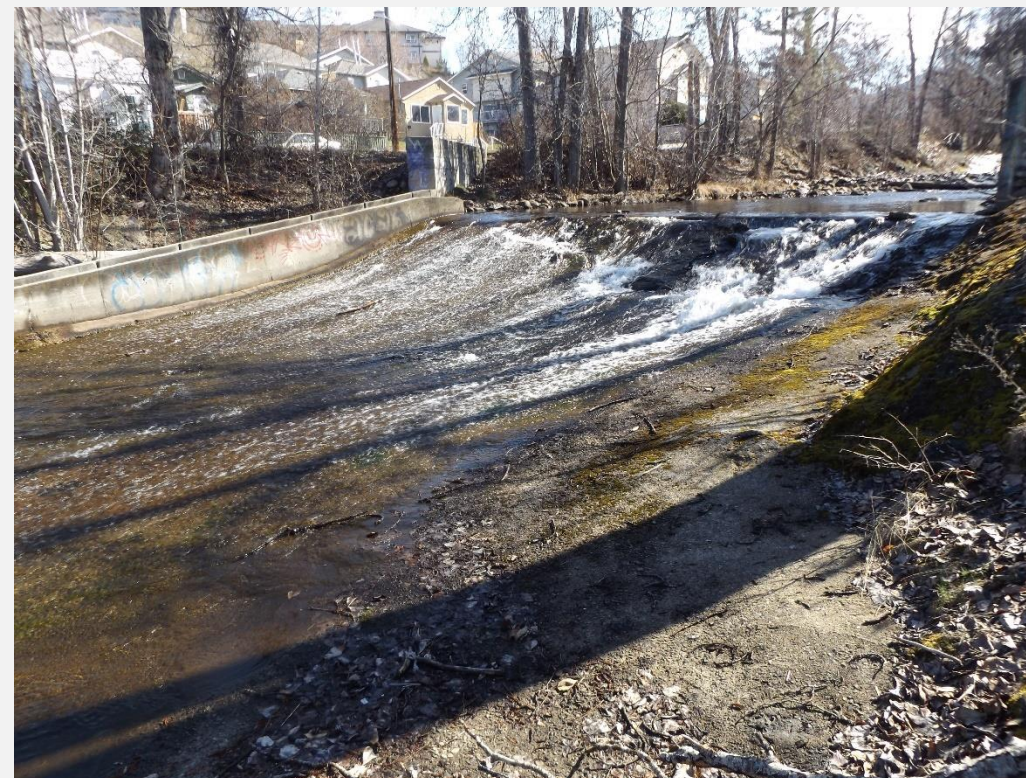
*Looking upstream at the concrete crest and apron of Structure #4*

Because there are no freeboard or lining deficiencies, most the restoration work in Reach 6 will be to remove and replace the concrete structures. Each will be replaced with a fish passable, single riffle of approximately 8% slope. These riffles will have a larger footprint than the existing structures, as the slope will be much lower than the concrete apron.

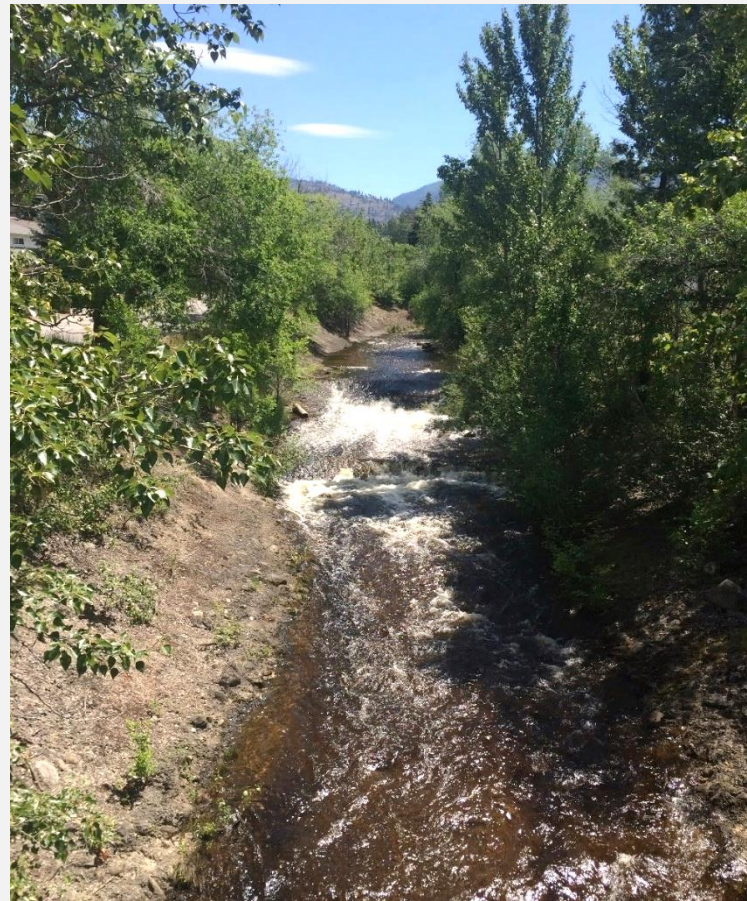
*Looking upstream at Structure #6, from the KVR pedestrian bridge*

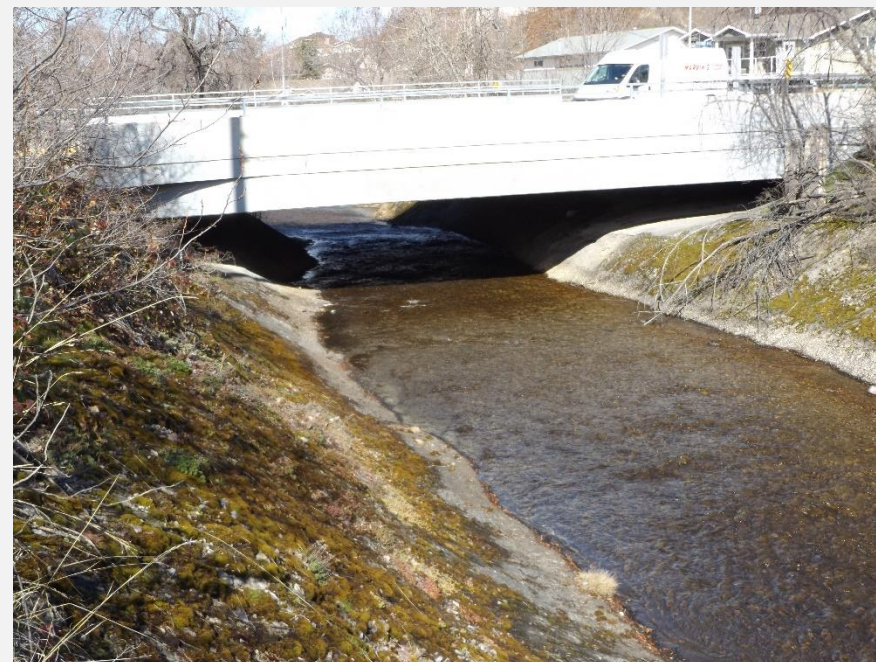
There is a lack of freeboard in the area around the crest of Structure #7, on the west side of the creek. Both the KVR pedestrian bridge and Eckhardt Avenue bridge have adequate freeboard compared to the adopted standard. However, the bridge at Eckhardt Avenue is considered a major transportation route for the City and work should be done to increase the existing clearance.

*Looking downstream at Eckhardt Avenue bridge*

The redesign of Structure #7 will move the crest further upstream, to increase freeboard (see Figure 7: Type A replacement). If a freeboard issue still exists, the banks must be heightened on the east side of the creek. To increase the clearance under Eckhardt Avenue bridge to a target of 1.5 metres, the concrete banks under the bridge should be removed as they restrict the cross-sectional area. The KVR pedestrian bridge does not require any work at this time.

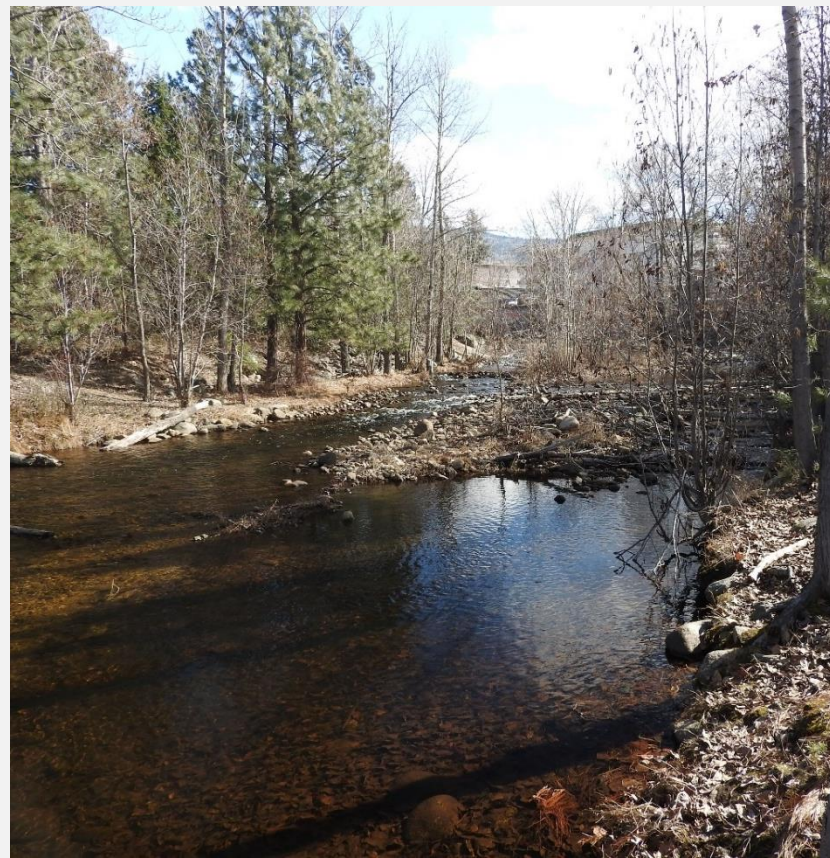
Looking upstream at creek braiding in Reach 8

Reach #8 is the most natural lower reach, with a wide cross section and a small floodplain. The slope is quite flat between structures and the rock size of the banks is stable during high flows. Some braiding has created a vegetated island, as seen above.

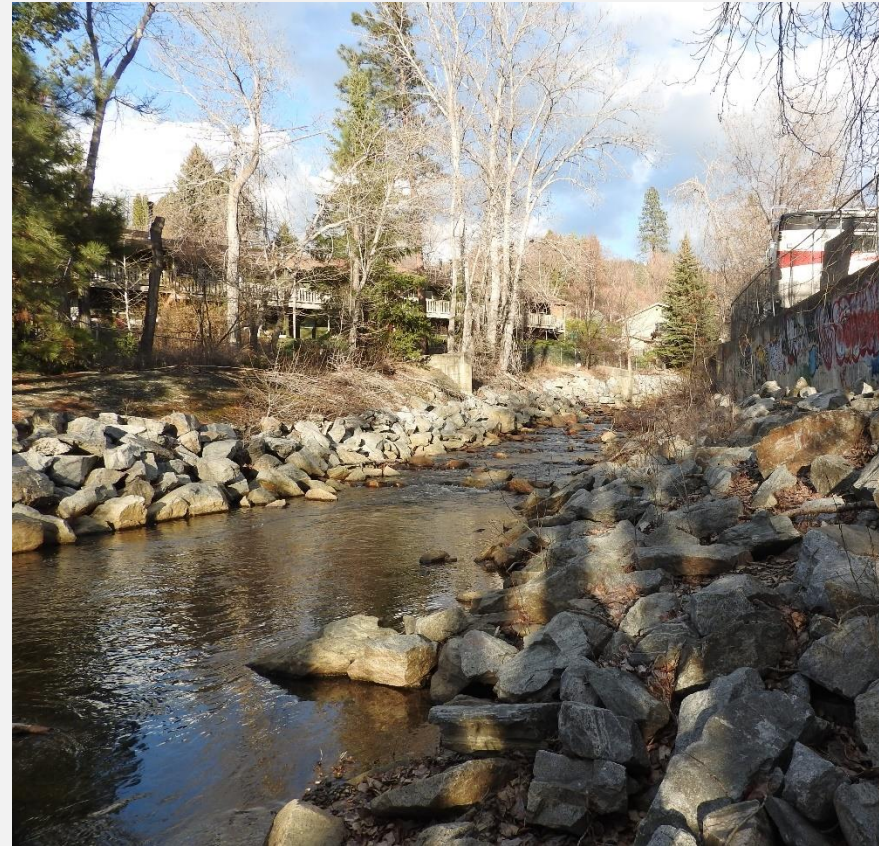
Reach 9 is a short and steep section of channel that has been repaired with riprapped banks by the City in the past. The structures in this reach have already failed and no longer have an impact on the water surface, although the concrete wingwalls still exist. The west side of the creek is bounded by a retaining wall for the parking areas of adjacent apartment buildings. On the east side, there are residence set slightly further back. The creek runs through private property for the entirety of this reach and within the M-185 Plan.

During the maximum daily and instantaneous flood flows, the slope and depth of water cause the size of the riprap to be unstable. There are no freeboard issues and no bridges in this reach.

*Looking upstream at Reach 9*

The restoration of Reach 9 will address the flood deficiencies by stabilizing the riprap and creating riffle and pool sequences to overcome the large elevation change. In addition, it is proposed that Reach 9 be widened to shift from a narrow channel to the broader floodplain of Reach 8. This will create an energy transition to ensure that a center torrent from Reach 9 will not destroy the works below.

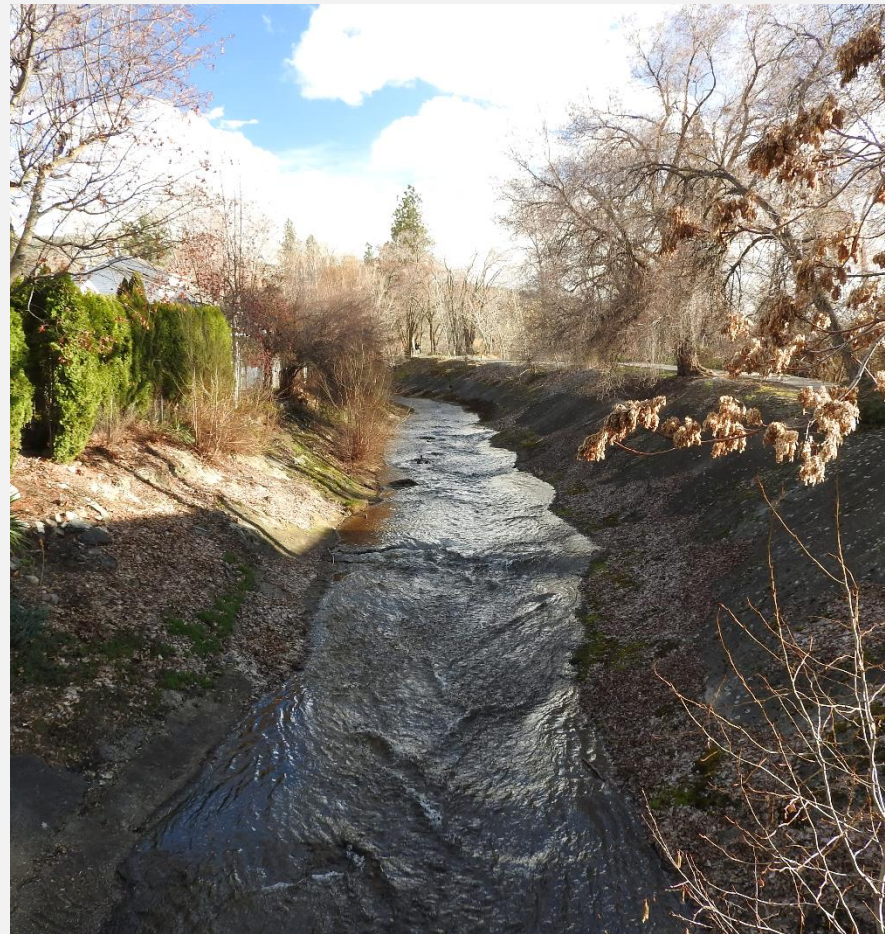
*Looking upstream from Forestbrook Drive bridge*

It is proposed that there will be no change under Forestbrook Drive bridge and the concrete liner will remain. However, it should be inspected at the time of work.

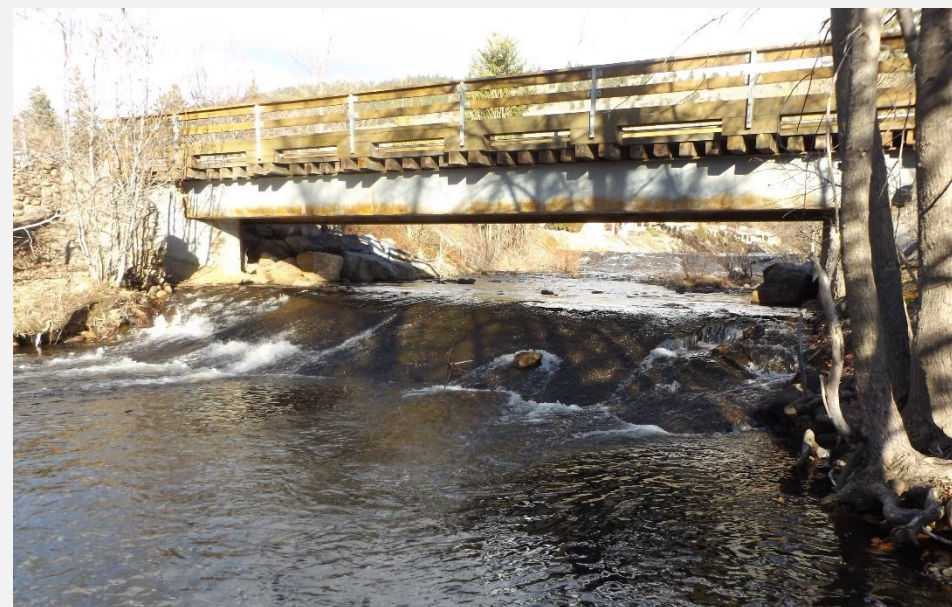
*View of McNicoll pedestrian bridge and Structure #26 from downstream*

McNicoll pedestrian bridge is located just above Structure #26, as seen in the photo to the left. One proposed option is that the structure be replaced with a riffle and moved upstream, to increase the area under the bridge to gain adequate clearance. Several other design options were discussed and further investigation will be needed during the detailed design phase.

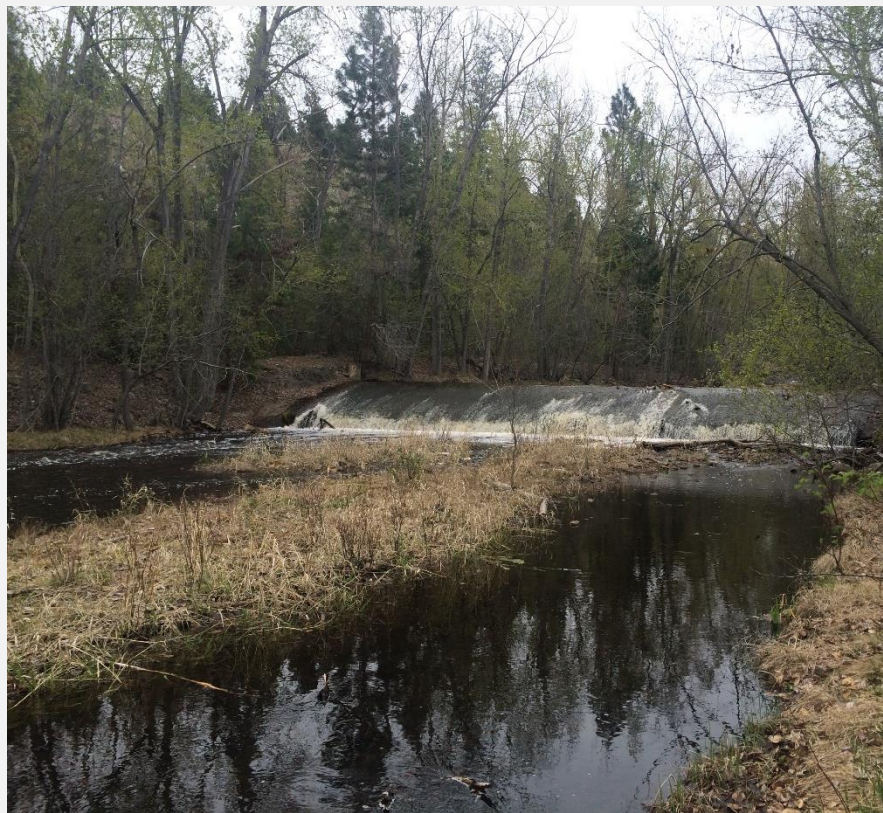
*View of a structure, looking upstream*

Reach 12 has three very large structures that are visibly failing and deterioration was seen during the preparation of the Master Plan. In addition, there is a lack of freeboard on the outside corner of the creek, near the pinchpoint of Penticton Avenue. This is on the border of Reaches 12 and 13, where there is currently a log boom.

It is proposed that each of the three large concrete structures will be replaced with a single riffle with a slope of 8%, which will be quite long due to the height of the structures (over 2 metres tall).

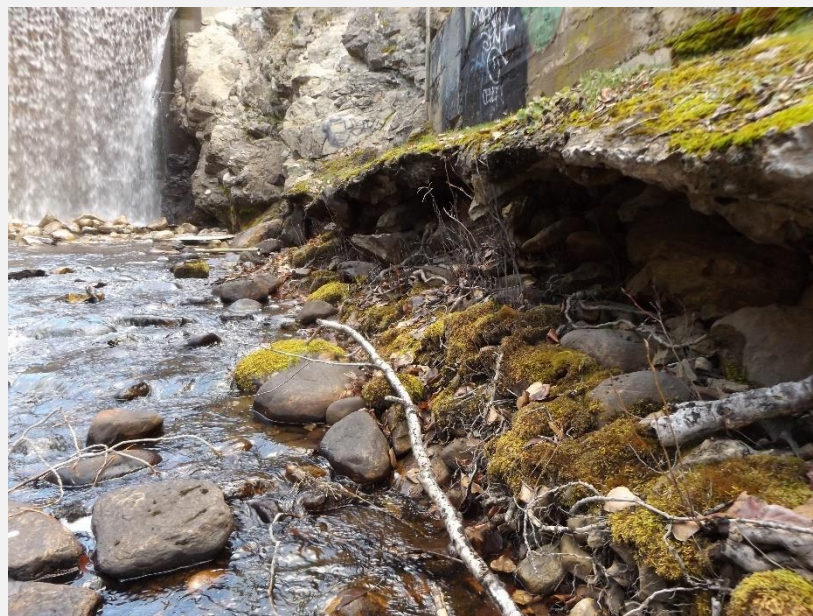
The natural rock in this area is too small to be stable at flood flows. Evidence of downgrading can be seen in areas where concrete was poured and is now not supported by the soils. The lack of freeboard discussed in Reach 12 continues into the lower part of Reach 13, along the outside corner. There are also two additional locations lacking bank

Evidence of Creek Downgrading Below Penticton Dam #2

In order to create a stable channel lining, a widened floodplain is proposed for the south side of the creek. This widening will not affect the original channel bottom. Where widening is not possible due to the proximity of the path or road, larger riprap will be placed to ensure the channel is stable. Small riffles can also be added to stabilize the rock. It is expected that large river rock will be found when working on this reach, which is a valuable resource that can be used in flatter reaches where the stable rock size is smaller.

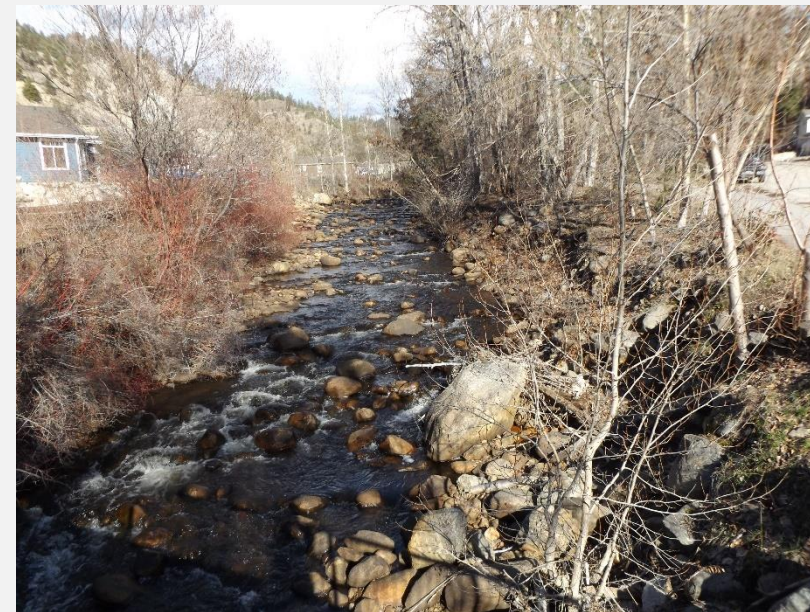
Looking upstream at Reach 13
